SECTION 319 NONPOINT SOURCE POLLUTION CONTROL PROGRAM

WATERSHED PROJECT FINAL REPORT

Segment 3C Characterization Project
Arrastra Basin
WQC02000019

ATTACHMENT 3
Macroinvertebrate Survey of Arrastra Creek, 2002

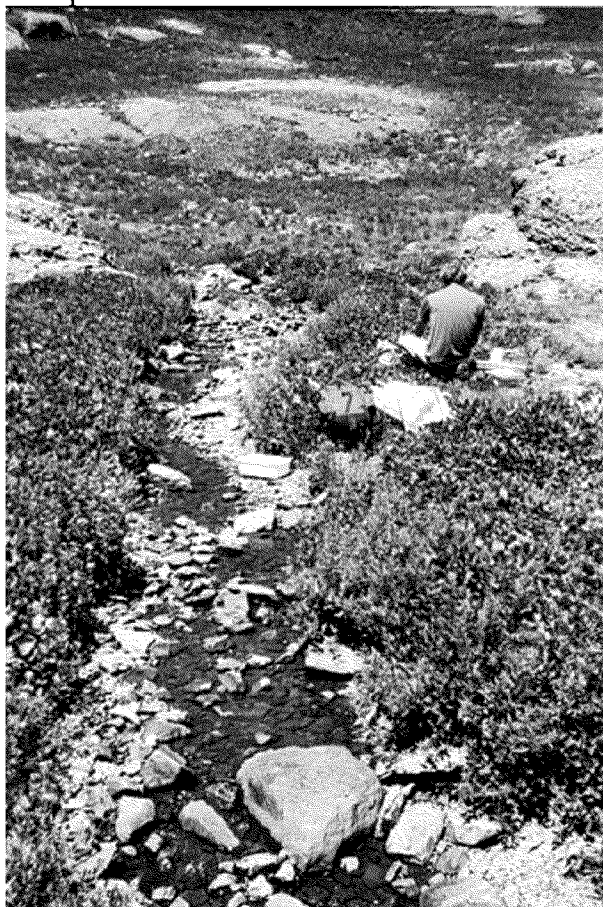
At this site Arrastra Creek was approximately 0.5 meters wide with less than 5cm of water flowing over pebble to boulder size substrate. Substrate was covered with adnate algae (fig. 2).

Figure 2. Silver Lake Inlet sample site.

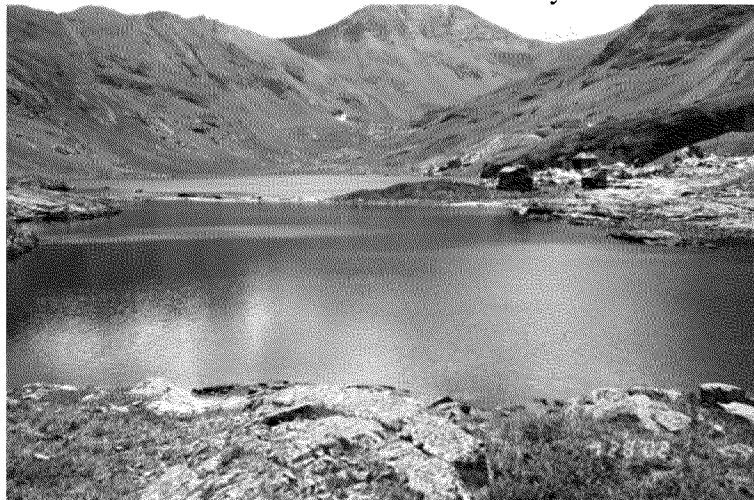
At this site the frame of the surber net was attached to a rope in 3 places and thrown into the lake and allowed to settle to the bottom. Then the net was pulled through the water to capture pelagic macro and meio invertebrates. No water chemistry data was obtained from this site (fig. 3).

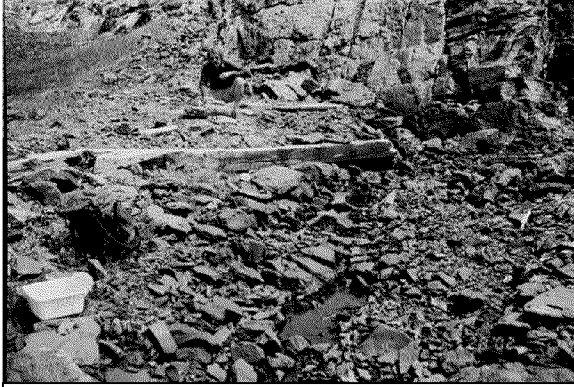
At this site the creek was small and warm with very little water running over boulders and bedrock. Wet substrate was covered with a small amount of adnate algae. Only macroinvertebrates were sampled at this site (fig. 5). Below this site there was no more surface water in the creek bed to at least the drop to the Mayflower mine.

Figure 5. Above Drop to Mayflower sample site.

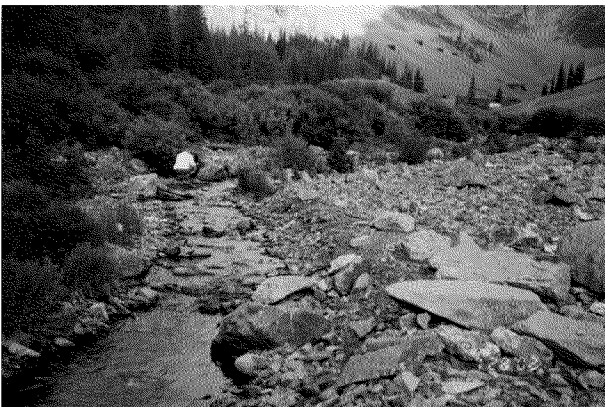
This site had no apparent difference in flow from the Above Quonset site. Moss was conspicuously absent and the boulder/cobble substrate was covered with adnate algae (fig. 7).

Figure 7. Below Quonset sample site.
